Technical Report GL-93-20  
August 1993

## **Effects of Variable Tire Pressure on Road Surfacing**

### **Volume I: Design, Construction, Behavior Under Traffic, and Test Results**

*by Robert W. Grau  
Geotechnical Laboratory*

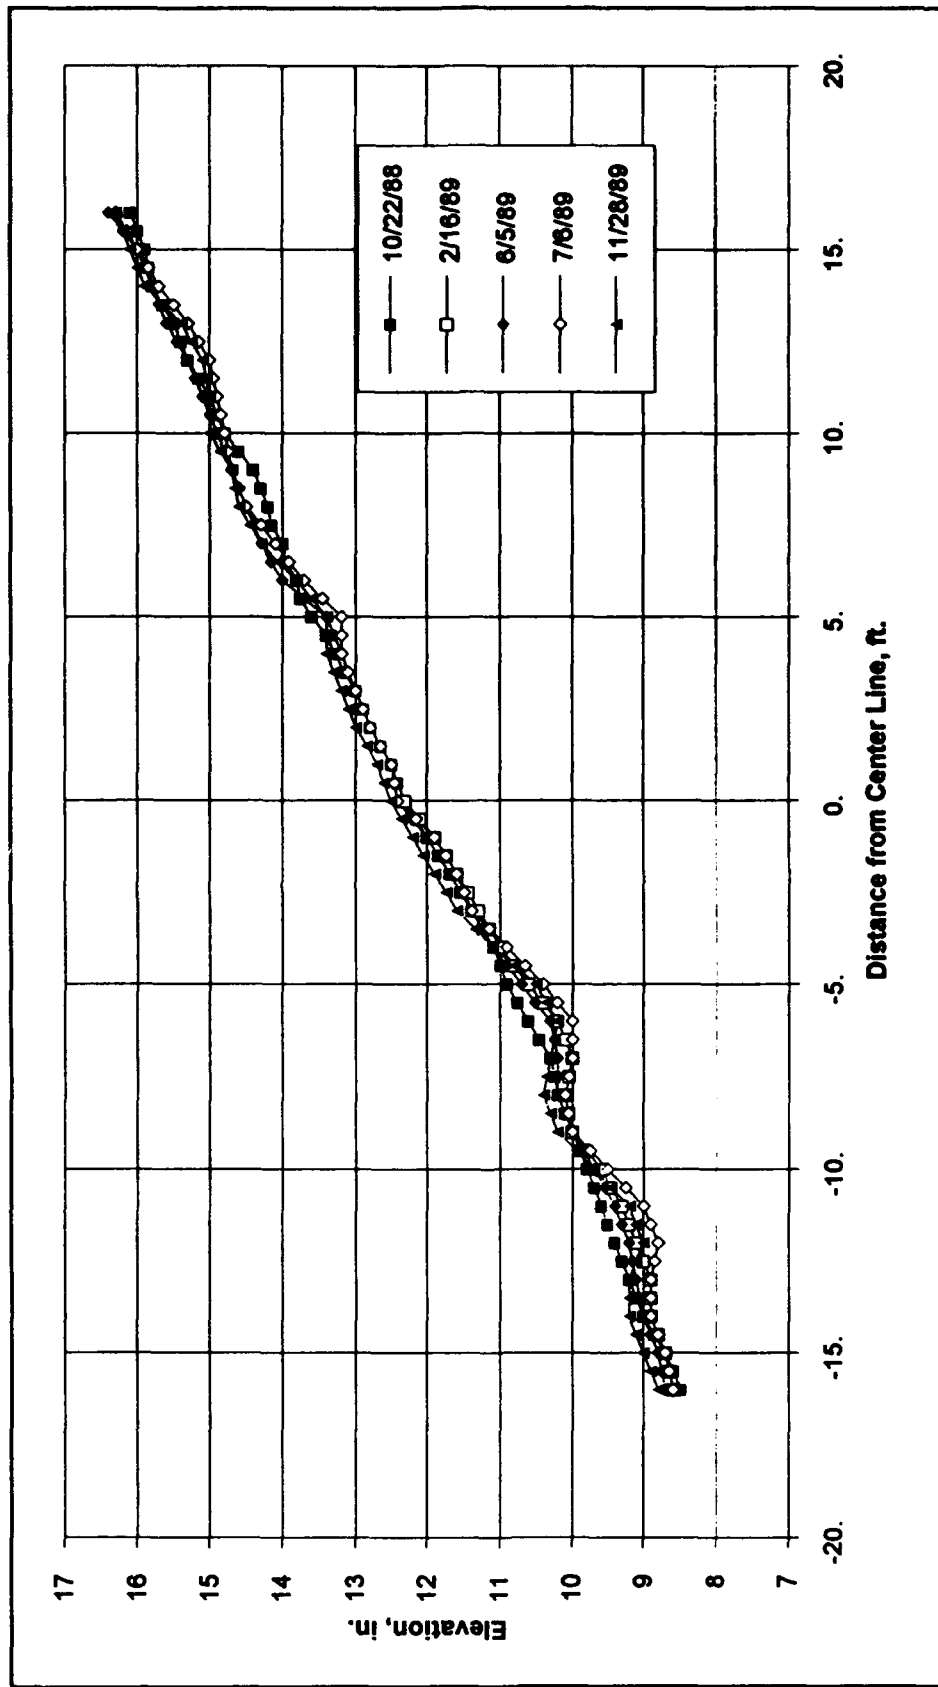
Figure 11. Item 8, sta 18 + 81, example cross section plot

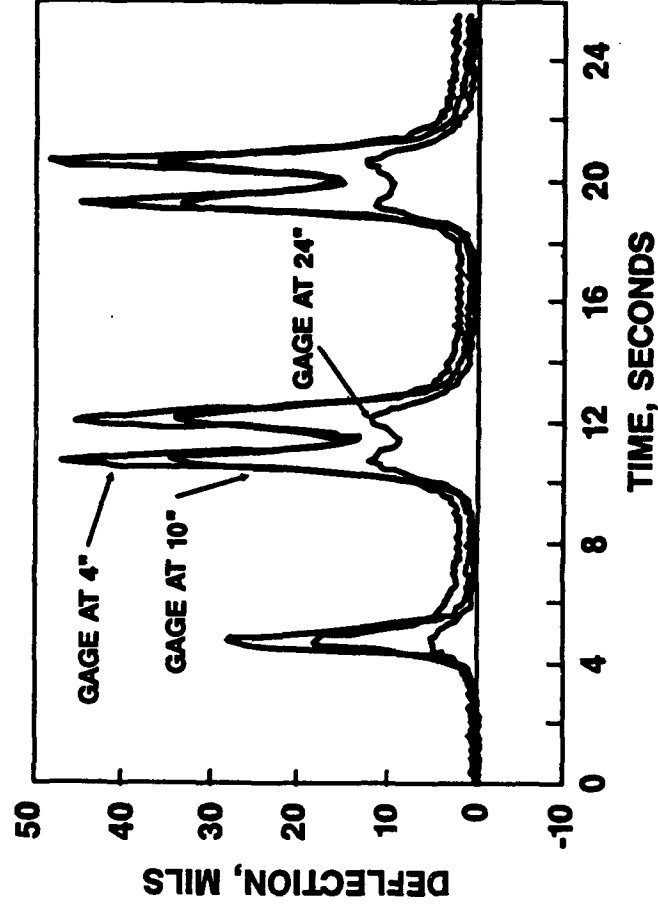
The loaded log trucks were used to apply dynamic loads to the MDDs. Both trucks were operated at various speeds over the MDDs installed in the high pressure and low pressure lanes in item 10 and over the MDDs positioned in the high pressure lane of item 12. Results of the measurements recorded during these tests are stored in the MDD1212 and MDD1111 directories. Each file in directory MDD1212 and MDD1111 are identified in Tables 21 and 22, respectively. These tables indicate the location of the MDDs (both item and lane) and the method of loading (FWD, HPT, or LPT) for the measurements recorded in each file. An example showing a portion of the measurements recorded by the MDD installed in item 10 is shown in Table 23. The first column of data in Table 23 indicates the time in milliseconds from the beginning to the end of testing and the remaining columns list the deflection in mils measured by the LVDTs during the test. Tests performed in item 10 have three columns of LVDT measurements while those performed in item 12 have two columns of LVDT measurements. LVDTs were installed at depths of 4.3-, 10.4-, and 24.2-in. at both MDD locations in item 10 and at depths of 5.0- and 17.3- in. for the MDD located in the high pressure lane of item 12. A typical response of the MDD in item 10 under loading of the high-tire-pressure truck operating at 2.1 mph is shown in Figure 12. Figure 13 shows plots of truck speed versus deflection based on the response of the MDD in the high pressure lane of item 10 loaded by both the high- and low-tire pressure trucks. As can be determined from these plots, the deflection of the pavement layers decreased as speed increased and also with lower tire pressures for the same gross loads. Approximately 10 percent more maximum deflection was measured in the high pressure lane of item 10 under the loads applied by the high-tire-pressure truck as compared to the deflections measured under the low-tire-pressure truck loads.

Figure 12. Typical MDD response under truck loading

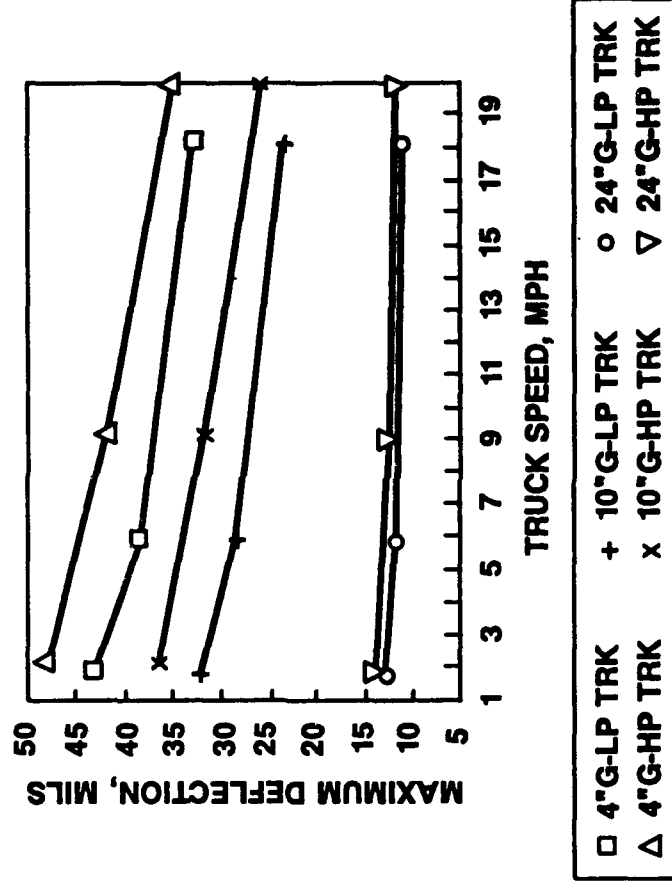
Figure 13. Typical MDD speed versus deflection for Item 10

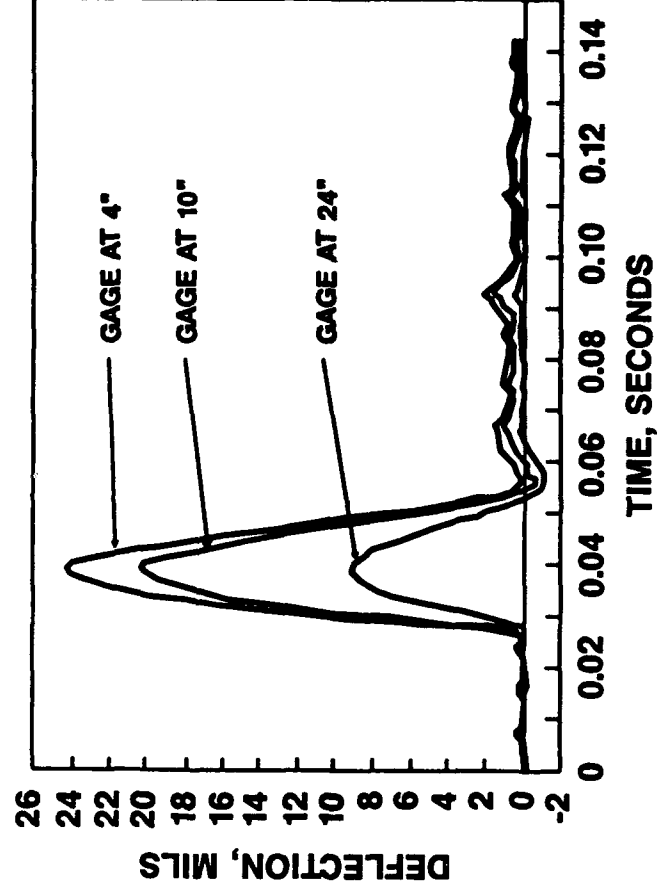
The FWD was also used as a loading device on the MDD instrumented test items. During these tests the FWD was operated at three drop heights and with the edge of the load plate located about 2 in. from the MDD. The loads produced at the three drop heights were about 6,000, 9,000, and 15,000 lb. The exact loads and corresponding deflection basin measurements recorded during these tests are presented in Table 24. The LVDT measurements recorded during each FWD test are stored in the file identified in the first column of Table 24. A typical response of the MDD in item 10 under a FWD loading is shown in Figure 14.

Figure 14. Typical MDD response under FWD loading
